Bioengineering Used to Stabilize Streambank Site on Turtle River

by Linda Kingery, Red River Basin Riparian Demonstration Project Coordinator

This article appeared in the "Quality Water: Newsletter of the North Dakota Nonpoint Source Pollution Task Force" Spring 1997 (Volume 8, No. 2)

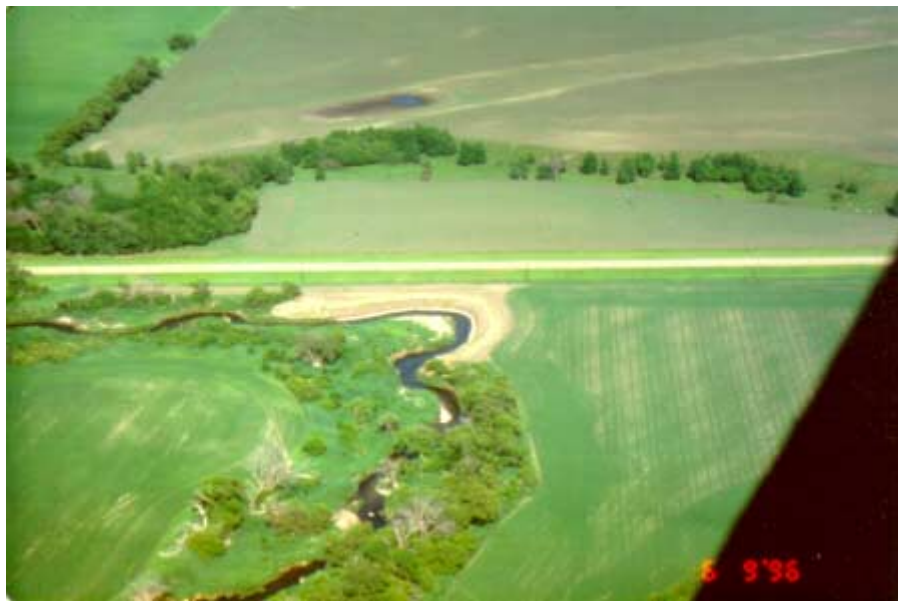
Aerial view of Turtle River riparian demonstration site

One demonstration site, the Turtle River site, is located two miles north of the junction of US Highway 2 and Grand Forks County 2 or “as the crow flies,” a mile east of Turtle River State Park. The area is prime farmland, and for the most part, a buffer of native bottomland hardwoods has been maintained. At the demonstration site, however, the lack of woody vegetation left the stream bank vulnerable to severe erosion. The situation

was compounded by groundwater seeps above the baseflow elevation of the river. During the period 1978 to 1995, the river migrated approximately 3.5 feet per year to the east until it was only 80 feet from the county road.

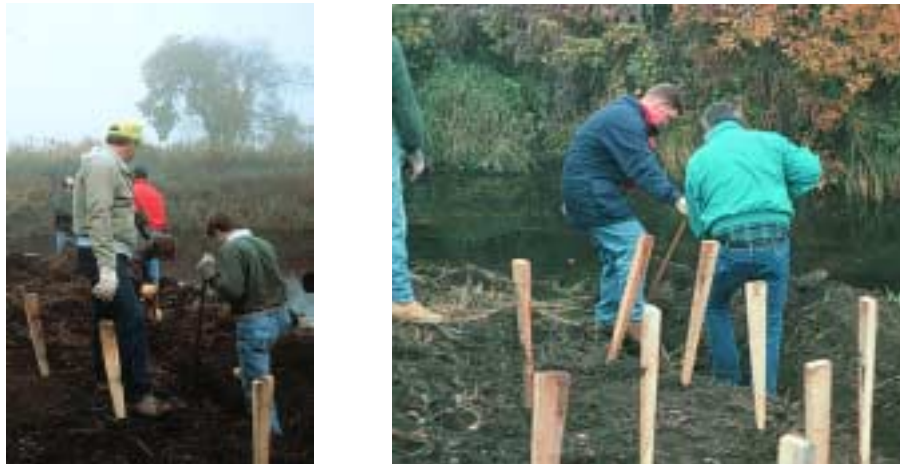
Resource managers used bioengineering at the Turtle River site in 1995

In order to stabilize the bank and stop further migration toward the road, several soil bioengineering techniques were implemented. The first step was to create a stable slope for the vegetation. The 14-foot vertical bank was reshaped to a 3:1 slope, with the waste from the top being used as fill at the toe. Then, riparian was installed along the toe to the bankfull elevation.

The participants then set to work installing a willow fascine in a trench just above the riprap. To make a fascine, willow branches 10 to 12 feet long were placed in a series of crossbucks to form a “rope” about 8 inches in diameter and 30 feet long. Twine ties were secured at 3-foot intervals along the fascine, which was then placed in the trench and secured with “stout stakes.” Two wedge-shaped stout stakes were created by ripping a 2 x 4 board 24 inches long diagonally.

A brush mattress to physically armor the bank was installed by placing a grid of stout stakes in the bank at 2- to 3- foot intervals. After the bank was covered with branches, wire was placed over the brush mattress and wrapped around the stakes to form a network over the mattress. Then the stakes were driven into the bank. Finally, “live” stakes were placed throughout the brush mattress. The brush mattress and fascine were partially covered with soil so that some branches and buds would be exposed to light.

A native grass mix was planted above the brush mattress, and two rows of shrubs were planted to complete the project.

The high flows experienced in the spring of 1996 tested the site. Significant erosion occurred along the top of the riprap, uncovering and undermining the fascine. The soil was replaced and subsequently washed away during another period of high flow. The site was repaired again by Americorp volunteers in early June. The pictures taken in September 1996 show that the mattress and fascine sprouted prolifically.
